## **Consequences of Massive River Bank Erosion to The Local Society at Pasir Parit, Kelantan**

See Too Kay Leng, Er Ah Choy\* & Mokhtar Jaafar

Social, Development and Environmental Research Centre, Faculty of Social Sciences and Humanities, Universiti Kebangsaan Malaysia, 43600 Bangi, Selangor, Malaysia.

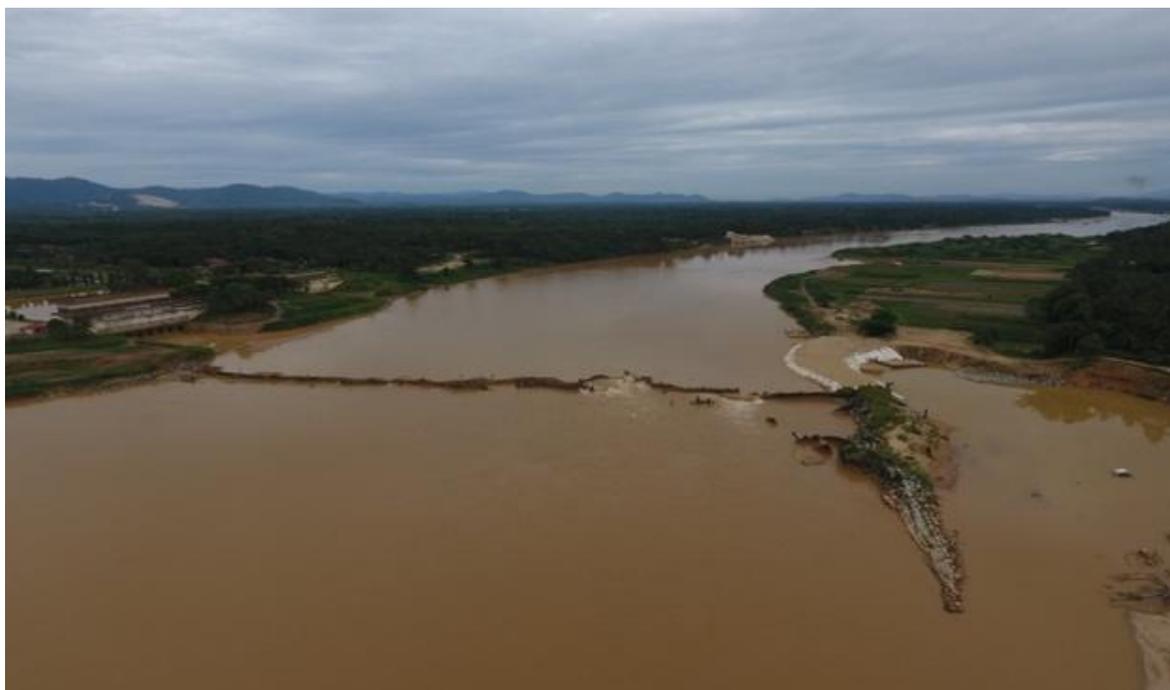
Figure 2. Barrier built across the river near the KADA pump house  
Source: Fieldwork on August 2018

This study also highlights the massive erosion that occurred at Kg. Pasir Parit as a result of the existence of a river barrier. The barrier is made of an iron rod and is around 6 metres tall (KADA, 2018). KADA built this barrier to divert water flow to their pump house, enabling them to provide water for farming and agriculture (Figure 2).

Massive river bank erosion occurred at Kg. Pasir Parit as a result of a KADA barrier built across the river. Furthermore, the investigation discovered that the soil texture of the river bank and riverbed was too poor, which may easily lead to erosion during rainy or flood seasons. Reconstructing the barrier, building gabion mattresses, reinforced concrete, and groynes are some practical procedures that may be used for the Kg. Pasir Parit river bank to avoid erosion. Because of the massive erosion of the river bank at Kg. Pasir Parit, it is no longer appropriate to apply landscape or vegetate methods to defend the river wall. The first step for officials is to rebuild the current barrier. The barrier cannot simply be used to obstruct the river flow, as shown in Figure 2c. Instead, authorities, namely KADA, must modify it to be more adaptable to silt and water movement.

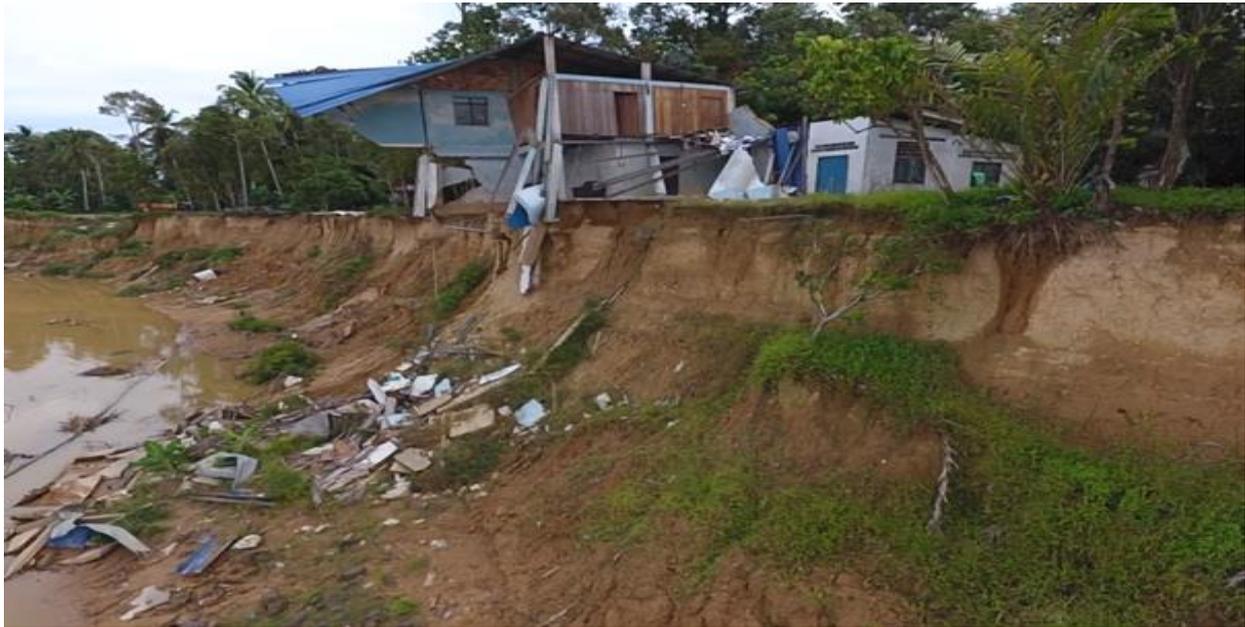
Figure 4. A house that collapsed due to massive river bank erosion

At Kg. Pasir Parit, the erosion of the river bank has had a substantial impact on the local human population. According to the study, the effects of bank erosion on humans include loss of settlement, land loss, trauma, and safety issues. People who reside along the river's edge have been forced to migrate. The most difficult aspect of relocating was that they didn't have another house to move to or land on which to construct their new home. The loss of their homestead renders them unable to live a respectable life (Figure 4). According to the information we have gathered through fieldwork, several victims have said that they would never relocate their homestead before the erosion occurred. The major reason for such behaviour is that they have insufficient

income to rebuild their houses before they completely collapse. During the interview, respondent A said that he was fortunate to be able to relocate to his second home, which was located a little farther away from the river bank. Respondent B, on the other hand, said that he does not know where to go if his home falls into the river as a result of the river bank's ongoing eroding. According to this issue, they said that government authorities such as KADA and DID would investigate and accept responsibility for their loss. However, the victims of river bank erosion did not get any compensation from them until August 2018.
